DEPARTMENT OF TRANSPORTATION

Contract #: 04-0120F4Cty: SF/ALA Rte: 80 PM: 13.2/13.9File #: 69.28**WELDING INSPECTION REPORT****Resident Engineer:** Pursell, Gary**Address:** 333 Burma Road**City:** Oakland, CA 94607**Report No:** WIR-004237**Date Inspected:** 08-Oct-2008**Project Name:** SAS Superstructure**OSM Arrival Time:** 1330**Prime Contractor:** American Bridge/Fluor Enterprises, a JV**OSM Departure Time:** 2230**Contractor:** Zhenhua Port Machinery Company, Ltd (ZPMC), Changxing Island **Location:** Shanghai, China

Bridge No: 34-0006**Component:** OBG Fabrication**Summary of Items Observed:**

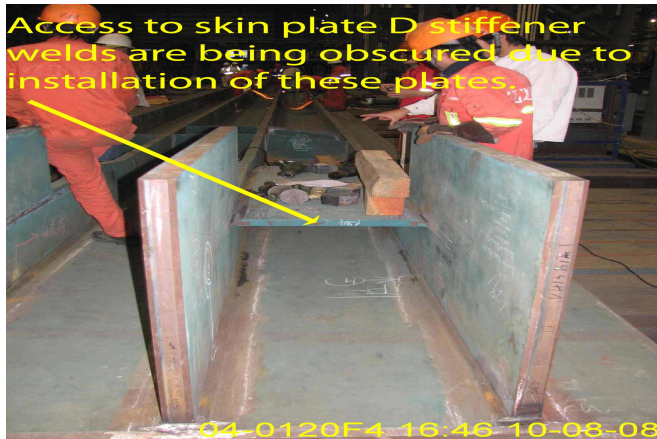
ABF informed the QA Inspector that the lower four meters of ESD1 Skin "D" stiffener to skin plate welds are ready for inspections and green tagging. ZPMC has requested that these areas be inspected first to allow installation of other plates that will obscure access to the stiffener plate welds. The QA Inspector performed random visual inspections of ESD1 Skin "DA" stiffener to skin plate welds and observed several weld locations that have areas in excess of 1 mm in depth below flush at the top of the welds and some welds have had the bottom toe ground and the weld profiles now have overlap conditions. ZPMC was informed and ZPMC performed repairs of these areas. The QA Inspector observed other portions of ESD1 Skin "D" appear to have loose pieces of asbestos on the top of the skin plate adjacent to the stiffener welds. The QA Inspector informed ABF representatives that this asbestos is a health hazard and should be properly removed and disposed.
